SCOTTISH
FIRE AND RESCUE SERVICE

Fire Investigation Report

The Glasgow School of Art

15 June 2018

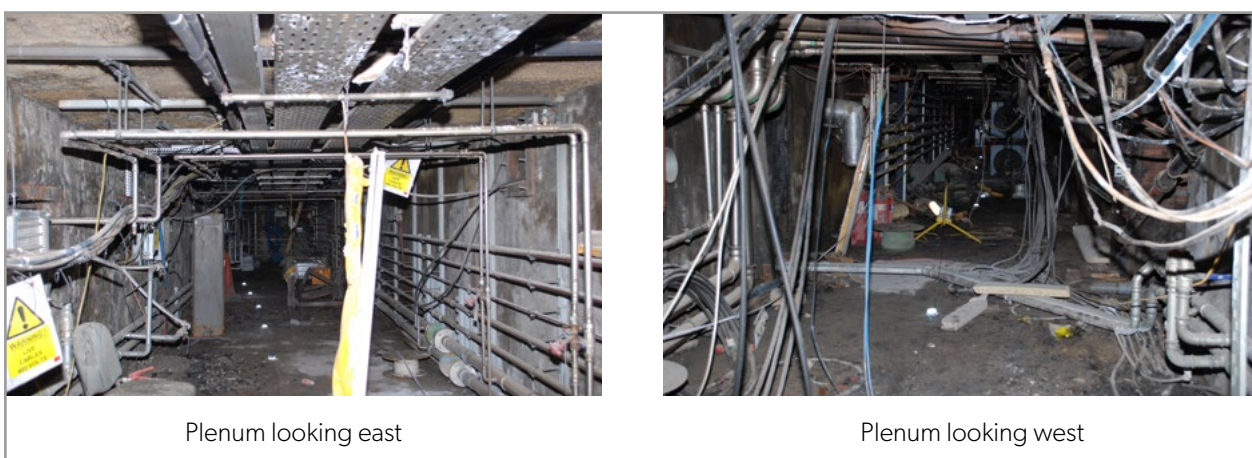
Figure 18 – Plenum below level 2

It was observed that the plenum had been utilised to route most of the electro-mechanical services for the building, including air conditioning ducts and fans, and a vast array of electrical and data wiring. Most of the wiring was observed to be secured to metal trays fastened at ceiling level. The majority of the plenum appeared to be undamaged by fire, with fire damage noted adjacent to vertical ducts which ran from numerous locations along the length of the plenum (Figure 18).

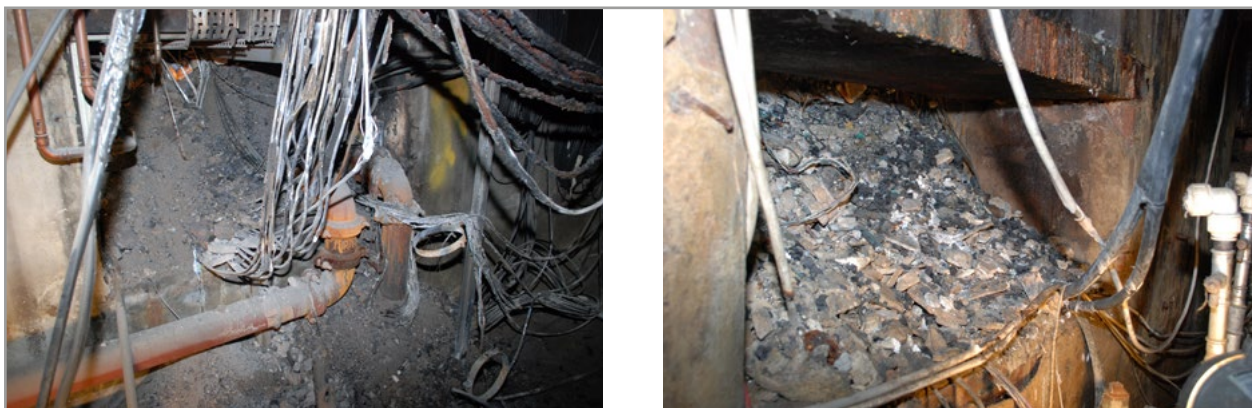
Figure 19 – Cables exiting vertical ducts into level 2 Plenum

The remainder of the vertical ducts located on the north wall and to the left of the plenum entry point (leading East), were excavated from the 4th to the 7th December 2019. The ducts were observed to contain general fire debris including bricks, mortar, wood ash and general fine dust. No large pieces of wood were observed or located within the ducts. Electrical cabling entering the ducts had sustained severe fire damage, with the remaining cable forming a tangled section within the fire debris located at the bottom of the duct (Figure 19).

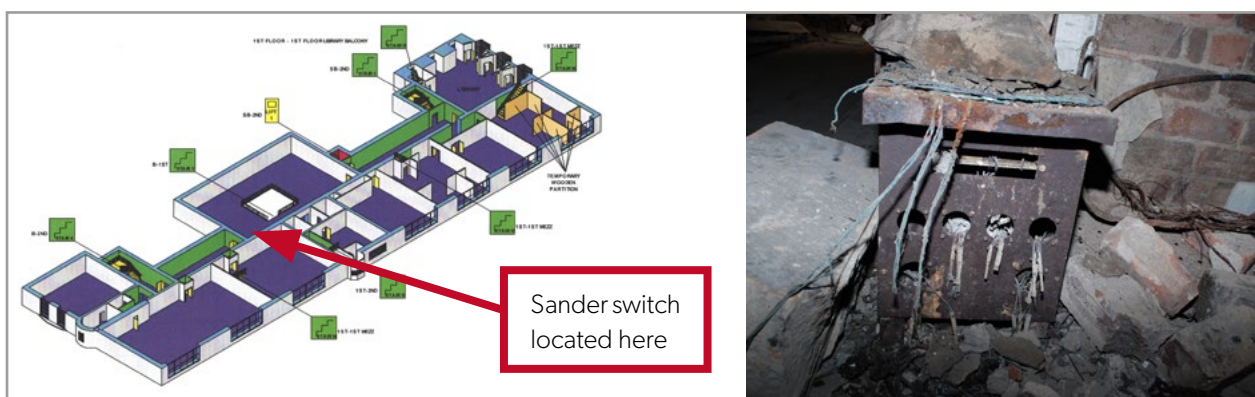
Figure 20 – Location of floor sander switch and the remains of one of nine 110volt site transformers

Several energised electrical supply cables were noted to be in use in a number of the vertical ducts. These supply cables served the lift, 110volt temporary site electrics and mains powered temporary site supplies. The mains powered cables supplied the contractors’ offices located in the east of the building (levels 2 and 3), and an electrical control switch for a floor sander located on level 6 (Figure 20).
