SCOTTISH
FIRE AND RESCUE SERVICE

Fire Investigation Report

The Glasgow School of Art

15 June 2018

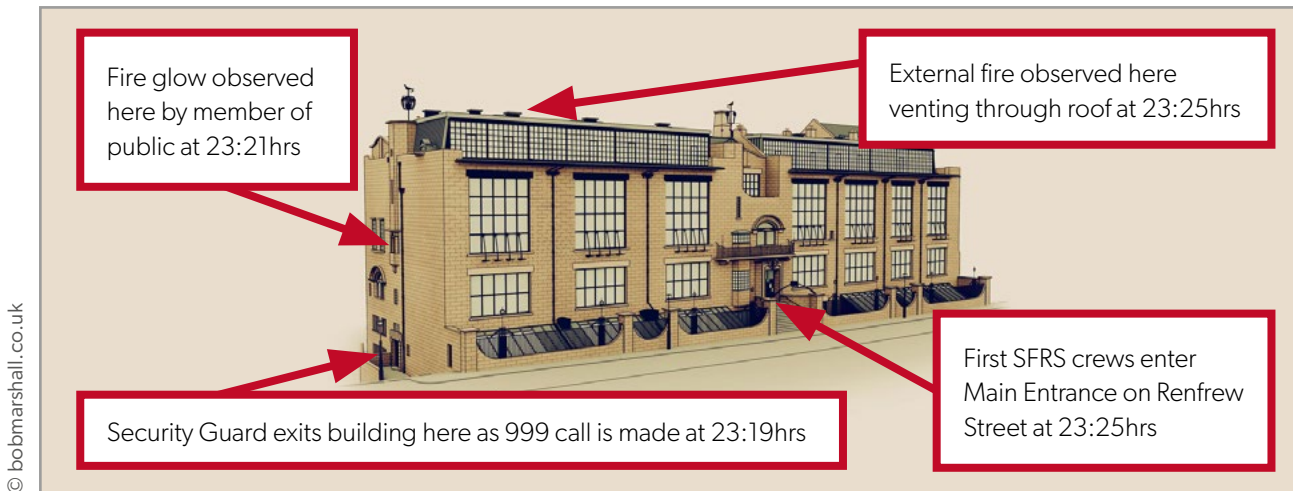
Figure 4 – Key points

The first RPs from Cowcaddens arrived at 23:25hrs with WC (**redacted**) as the initial IC. His initial action was to speak with the persons at the location and gather as much information as possible. At 23:29hrs a further RP from Maryhill arrived and liaised with the IC.
